**Flood Control Project Maintenance
Levee Inspections**

Maintenance Issue Types Only, Levee Inspection Report By Mile - Spring 2018

Tehama County Flood Control and Water Conservation District

Waterway	Bank	Unit Miles	Inspection Start/End	Inspector
Unit No. 01 Deer Creek	Left	4.22	04/04/2018 04/04/2018	Bob Duffey

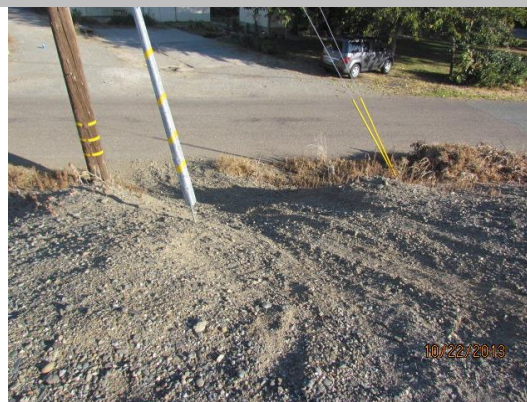
Photo 1 of 1 : SP_2018_NA0019_81_12_20180305_00007.jpg

LM Start	2.32	Rating **	M	Issue No.	12
LM End	2.32	Issue Type +	Ma	Location *	LS
Category	Earthen Levee			GPS Latitude/Longitude	
				Start	End
Item	Slope Stability			40.052443 °	40.052443 °
				-122.148863 °	-122.148863 °
DWR ID	DWR_NA0019_04_f_2013_12				
Comment Code					
S3 : Repair the levee slope damaged by vehicle traffic and prevent access where possible.					
Inspector Comment

View of the slope instability caused by vehicles along the landside slope.

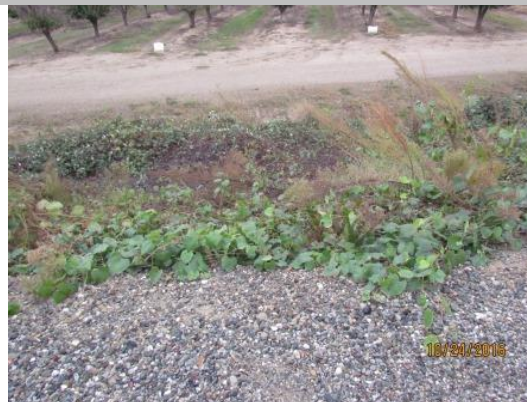
Photo 1 of 1 : SP_2018_NA0019_81_39_20180305_00022.jpg

LM Start	3.40	Rating **	M	Issue No.	39
LM End	3.44	Issue Type +	Ma	Location *	LS
Category	Earthen Levee			GPS Latitude/Longitude	
				Start	End
Item	Vegetation			40.056546 °	40.055906 °
				-122.133530 °	-122.133294 °
DWR ID	DWR_NA0019_04_f_2016_39				
Comment Code					
V2 : Remove the wild growth other than native grasses from the levee slopes.					
Inspector Comment

View of the blackberries along the landside slope blocking visibility and access.

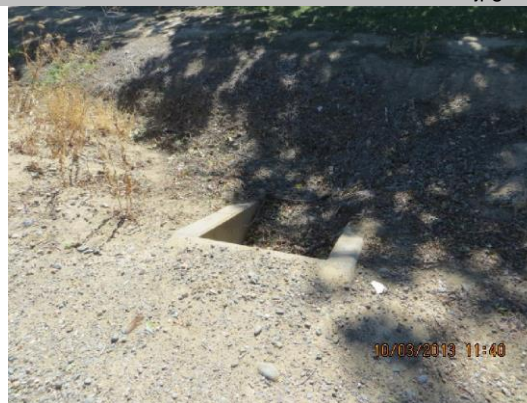
Photo 1 of 3 : UCIP_SP_2018_21744_36945.jpg

LM Start	0.11	Rating **	A/W	Issue No.	20
LM End	0.11	Issue Type +	Ma	Location *	
Category	Supplemental			GPS Latitude/Longitude	
				Start	End
Item	DWR UCIP LMA Responsibility			40.051702 °	40.051702 °
				-122.189922 °	-122.189922 °
DWR ID					
Comment Code					
Inspector Comment					
FS_ID:21744					
DS_ID:20799					
EP_NO: N/A					
Repair Type: No Action Needed					
Crossing Status: Found					
UCIP Comments:					
FIELD_STRUCT_DESC: 24-inch corrugated metal drainage pipe through the levee, 5.4 feet below the crown. Flap gate on the waterside (WS) end. Concrete U-shaped headwalls on the WS and landside (LS) ends. [Additional Reference(s): DWR Levee Log, 1992. USACE Sacramento O&M Manual 510, April 1963, (HLM 0.11) Drawing No. 50-4-3622].					
FS Date: 10/3/2013

Concrete headwall on LS toe.

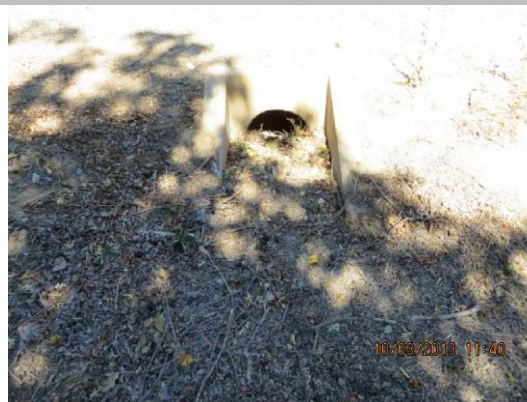
Photo 2 of 3 : UCIP_SP_2018_21744_36944.jpg

Concrete headwall on LS toe.

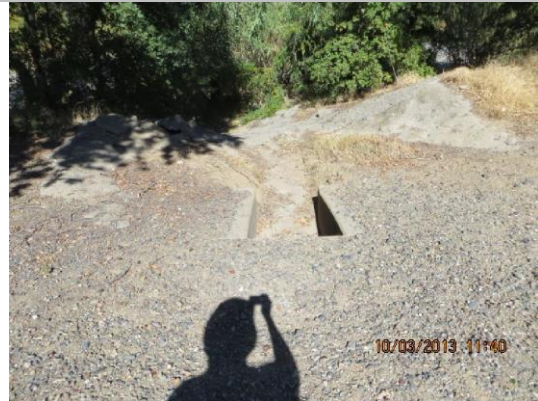
Photo 3 of 3 : UCIP_SP_2018_21744_36943.jpg

Concrete U-shaped headwall on WS slope.

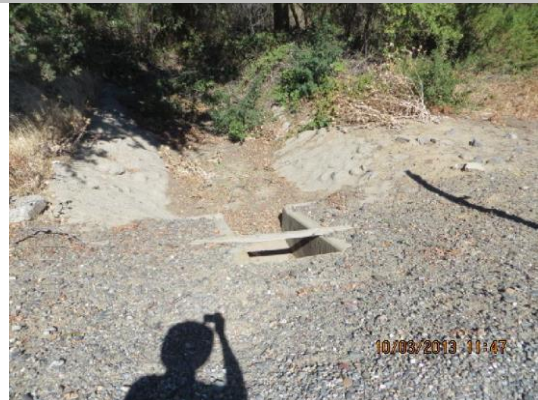
Photo 1 of 3 : UCIP_SP_2018_41124_36953.jpg

LM Start	0.50	Rating **	M	Issue No.	21
LM End	0.50	Issue Type +	Ma	Location *	
Category	Supplemental			GPS Latitude/Longitude	
				Start	End
Item	DWR UCIP LMA Responsibility			40.050585 °	40.050585 °
				-122.182972 °	-122.182972 °
DWR ID					
Comment Code					
Inspector Comment					
FS_ID:41124 DS_ID:20801 EP_NO: N/A Repair Type: Non-Urgent Crossing Status: Found UCIP Comments: Debris inside pipe at WS toe needs to be removed as it may prevent proper operation of the flapgate. FIELD_STRUCT_DESC: 24-inch corrugated metal drainage pipe through the levee, 5.2 feet below the crown. Flap gate on the waterside (WS) end. Concrete U-shaped headwalls on the WS and landside (LS) ends. [Additional Reference(s): DWR Levee Log, 1992. USACE Sacramento O&M Manual 510, April 1963, (HLM 0.51) Drawing No. 50-4-3622]. FS Date: 10/3/2013

Concrete headwall on WS toe.

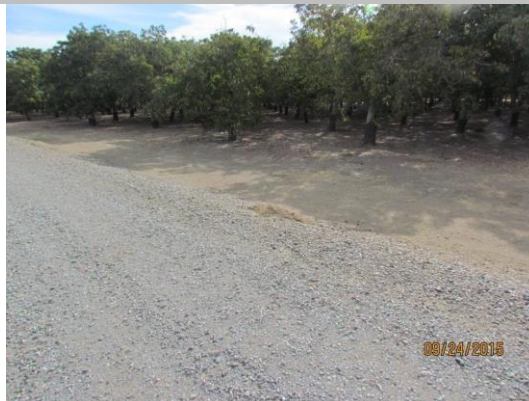
Photo 1 of 1 : SP_2018_NA0019_82_8_20180305_00003.jpg

LM Start	0.94	Rating **	M	Issue No.	8
LM End	1.05	Issue Type +	Ma	Location *	LS
Category	Earthen Levee			GPS Latitude/Longitude	
				Start	End
Item	Animal Control			40.051360 °	40.052361 °
				-122.175063 °	-122.173450 °
DWR ID	DWR_NA0019_05_f_2015_8				
Comment Code					
A1 : Exterminate rodents and backfill and compact or grout burrows.					
Inspector Comment					
Repair rodent hole on landside slope.

View of the rodent holes along the landside slope.

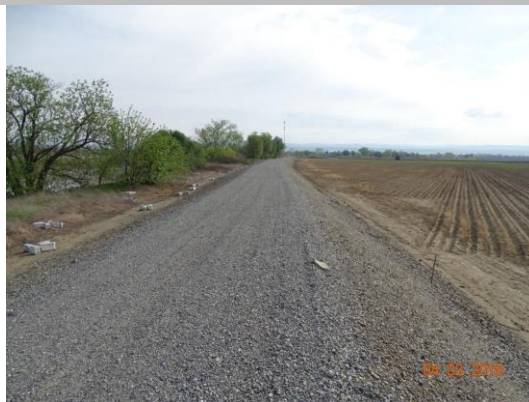
Photo 1 of 1 : SP_2018_NA0019_82_16_20180405_00020.jpg

LM Start	1.57	Rating **	A	Issue No.	16	
LM End	1.57	Issue Type +	Ma	Location *	LS	
Category	Earthen Levee			GPS Latitude/Longitude		
				Start		End
Item	Vegetation			40.050808 °		40.050808 °
				-122.164423 °		-122.164423 °
DWR ID	DWR_NA0019_05_s_2018_16					
Comment Code						
V1 : Control annual grass and weeds on the levee slopes and easements.						
Inspector Comment						
The vegetation was removed from both slopes.

View of no vegetation on both slopes.

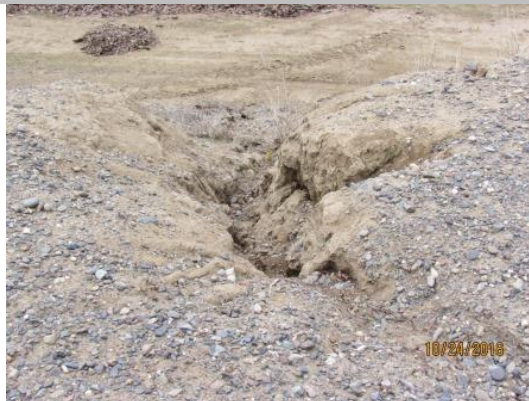
Photo 1 of 1 : SP_2018_NA0019_82_18_20180305_00007.jpg

LM Start	3.76	Rating **	U	Issue No.	18
LM End	3.76	Issue Type +	Ma	Location *	LS
Category	Earthen Levee			GPS Latitude/Longitude	
				Start	End
Item	Erosion / Bank Caving			40.054829 °	40.054829 °
				-122.129329 °	-122.129329 °
DWR ID	DWR_NA0019_05_f_2016_18				
Comment Code					
E2 : Schedule repair of erosion site prior to the next inspection.					
Inspector Comment

View of the erosion along the landside slope.
